Nanotechnology: Science meets machine reliability

Our ability to measure surface asperities with far greater precision is extending component lifecycles.

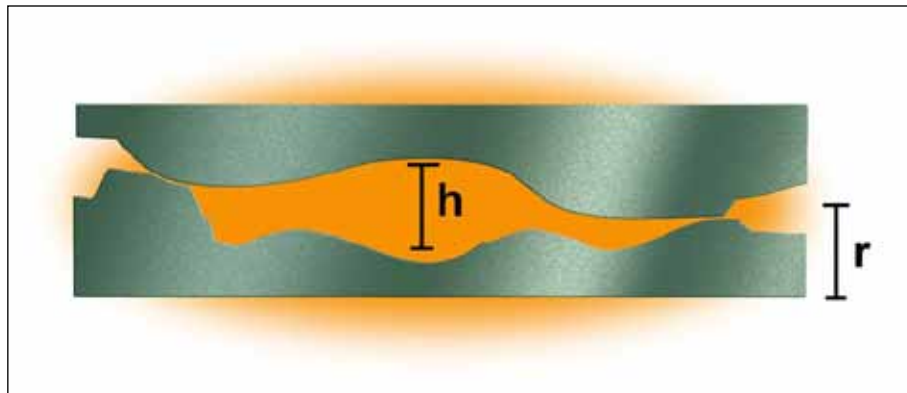
Figure 2 | The relationship between combined surface roughness of two surfaces and film thickness requirement.

Figure 2 describes the importance of surface finish, demonstrating the mean asperity height (r) and showing

that the combined asperity heights (h) must be cleared in order to avoid adhesive or abrasive wear on one or both surfaces.

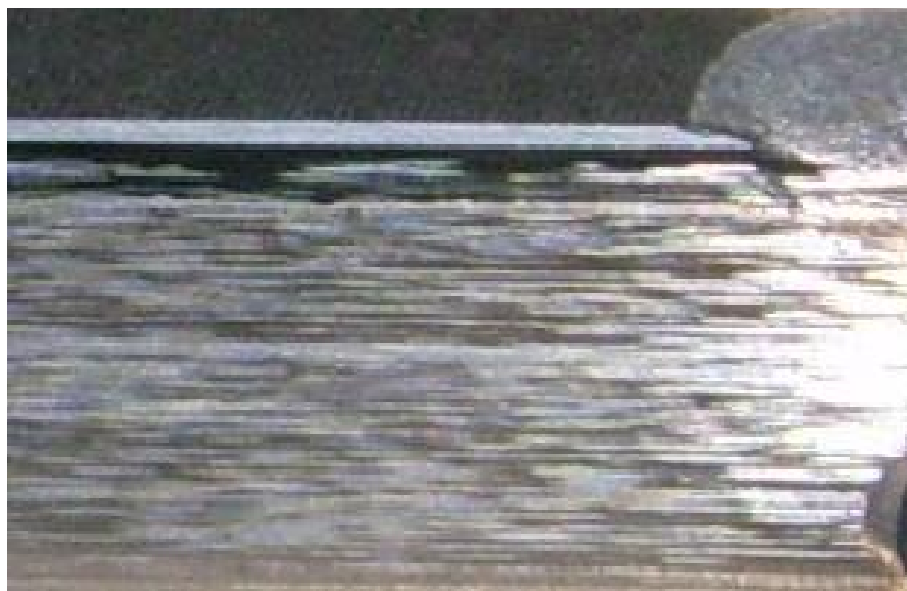
Figure 3 | Surface of a rough gear flank from a wind turbine drive.

Figure 3 shows the expected result that occurs to machine surfaces due to a combination of lubrication-related

factors, some of which are avoidable with improved maintenance and design. Improved maintenance tactics alone do not overcome inadequate design.

For the sake of visual comparison, the gear flank shown for its roughness in Figure 3 is shown again beside the microtopograph in Figure 6.

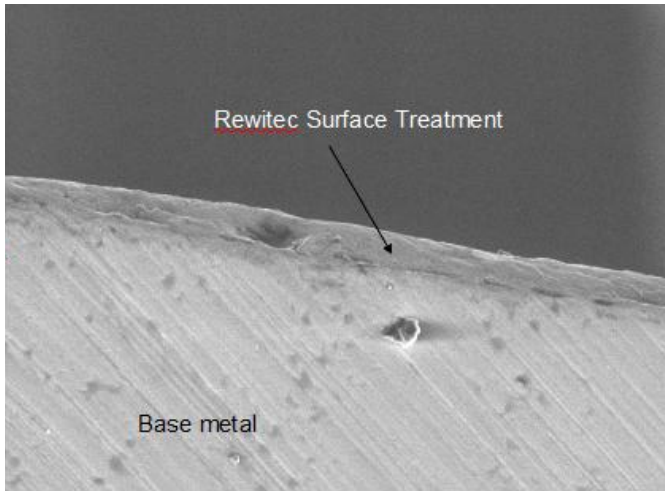
Figure 4 | Ceramic-like metal-silicate layer formation produced by chemical reaction at a highly loaded machine surface.

The active ingredient contains various silicates, as reported by the producer. The introduced solids produce a chemical reaction with the lubricated machine element (such as a gear, engine cylinder and bearing race) due to high partial pressure and temperatures during contact. The silicate atoms of the active ingredient conjoin with metal atoms of the metal surface and compose the ceramic-like metal-silicates layer. Figure 4 provides a graphic example of the metal-silicate layer.

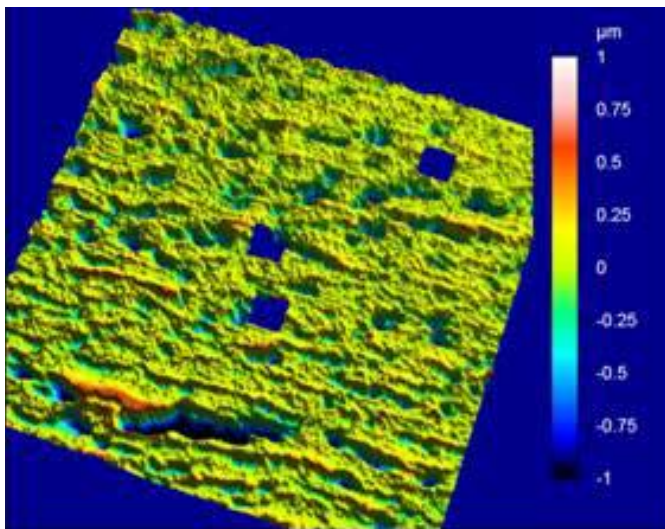
Figure 5(a) | Wind turbine gear surface profile following use and before treatment.

Independent analysis of surface imprints using MuSurf (µSurf) Topometry by NanoFocus AG suggests appreciable change in surface roughness on worked surfaces following treatment. Figures 5 and 6 provide a contrast of surface profiles from a silicon imprint of the surface noted in Figure 3, contrasting change in condition through the nanocoating treatment.

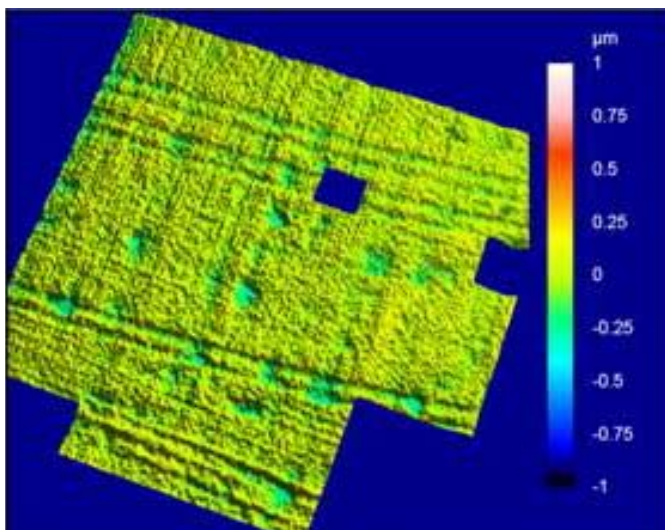
Figure 5(b) | The identical cross section of wind turbine gear surface profile noted in Figure 5 following treatment.

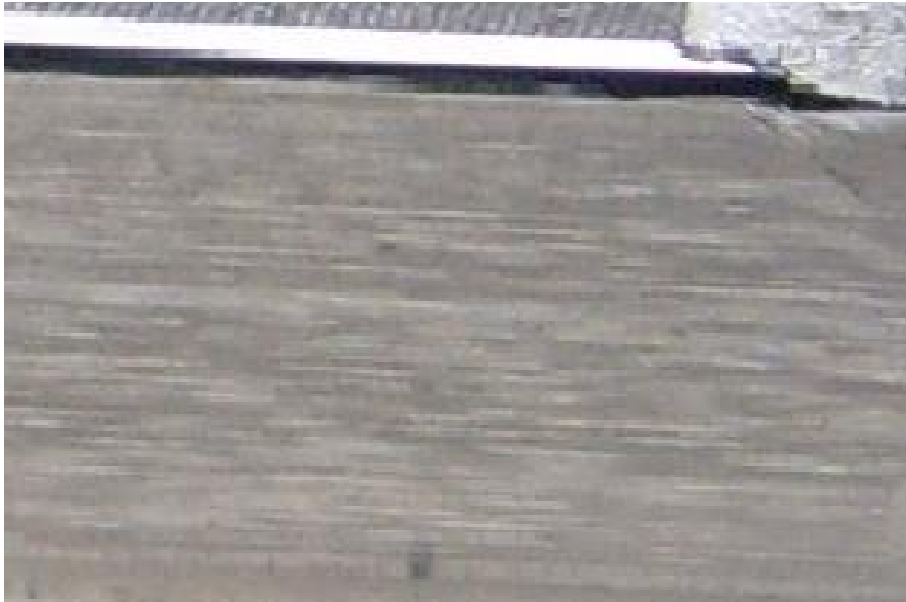
Figure 6 | Wind turbine gear drive flank after surface conditioning.

The blue square patches in the green area represent dust or contaminants on the samples that the software automati-

cally extracted from measurement and comparison. The scale is noted on the right axis and ranges between 1 and -1 microns. The change in the roughness condition is noteworthy. This type of

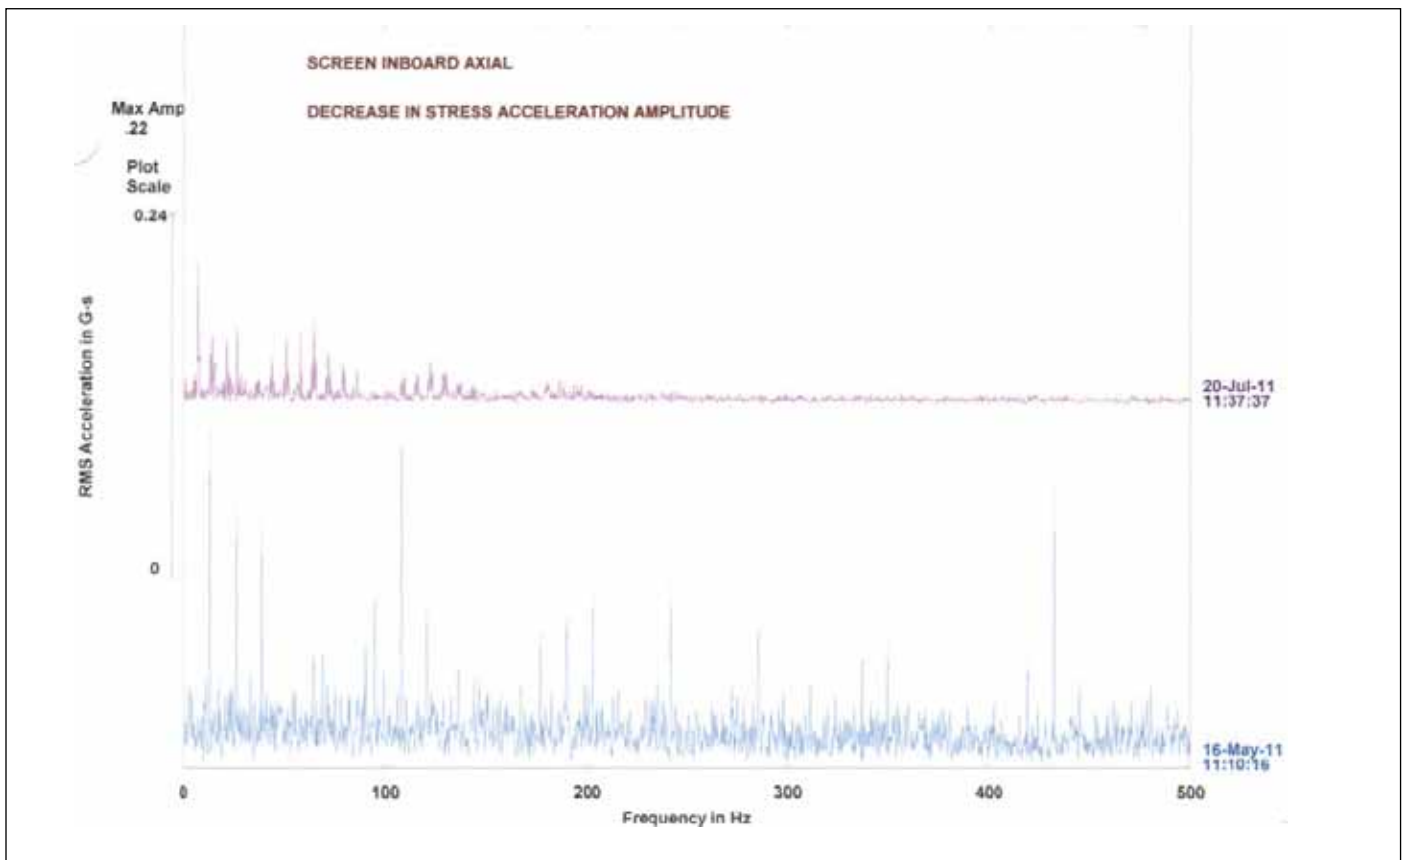
Figure 7 | Stress acceleration readings reveal lower energy levels associated with surface roughness and oil film effectiveness following treatment.

The plot in Figure 7 shows the change in stress acceleration level on the bottom inboard bearing of a shaker screen in the axial position. Measurements shown in Figure 7 were taken in mid-May and then again in mid-July following treatment of the oil lubricated bearing, with the same oil in use. The operating load and speed is the same in both instances. The change in readings suggests a significant change in asperity (surface) contact rate following treatment.

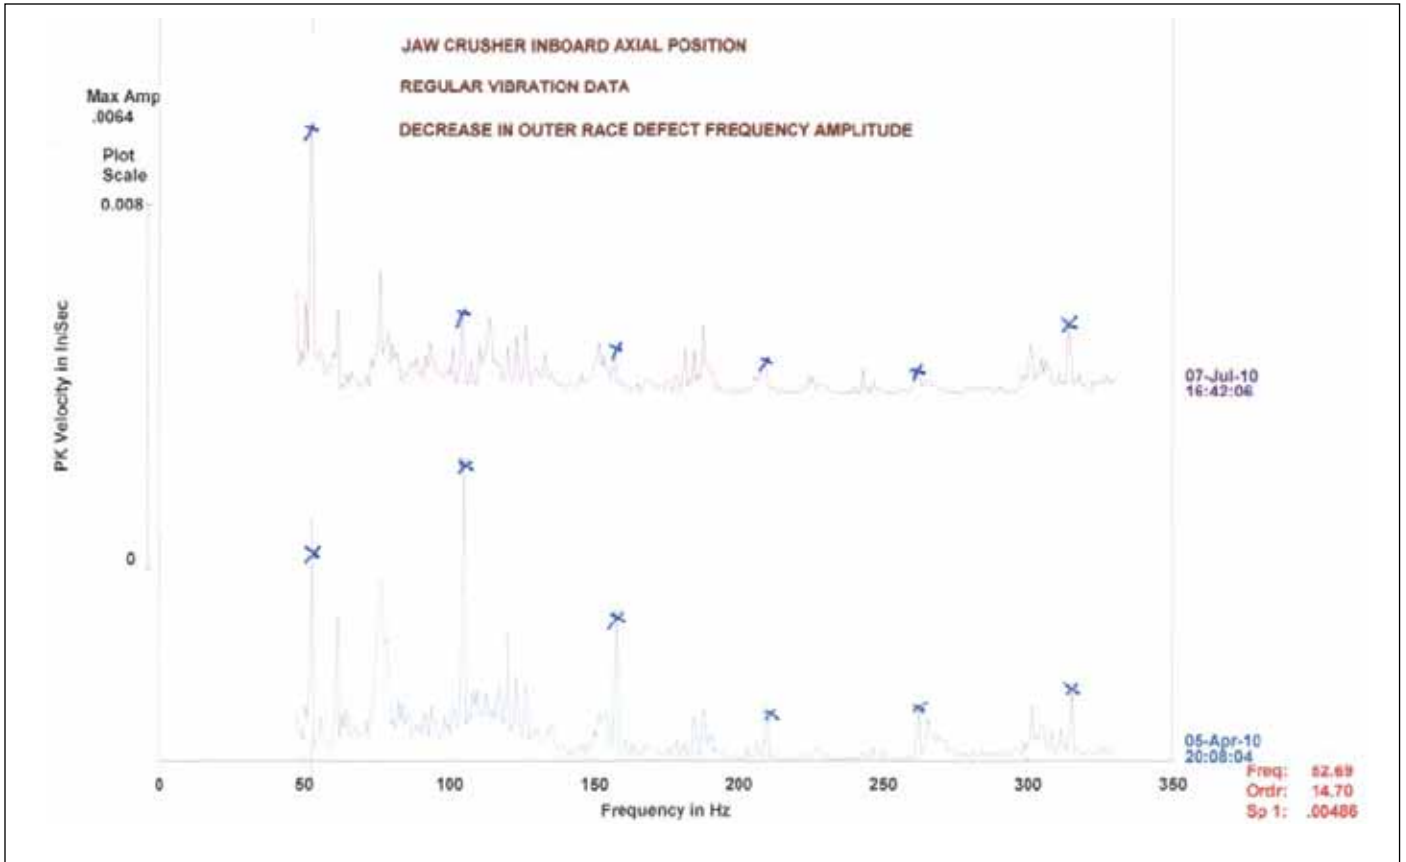
Figure 8 | Overall vibration readings for the inboard shaft bearing.

Figures 8 and 9 provide plots of data comparing before and after treatment. Figure 8 is a regular vibration reading and Figure 9 is a stress acceleration reading. Both show significant

change in energy level that is consistent with expectations promoted by the treatment supplier, Rewitec.

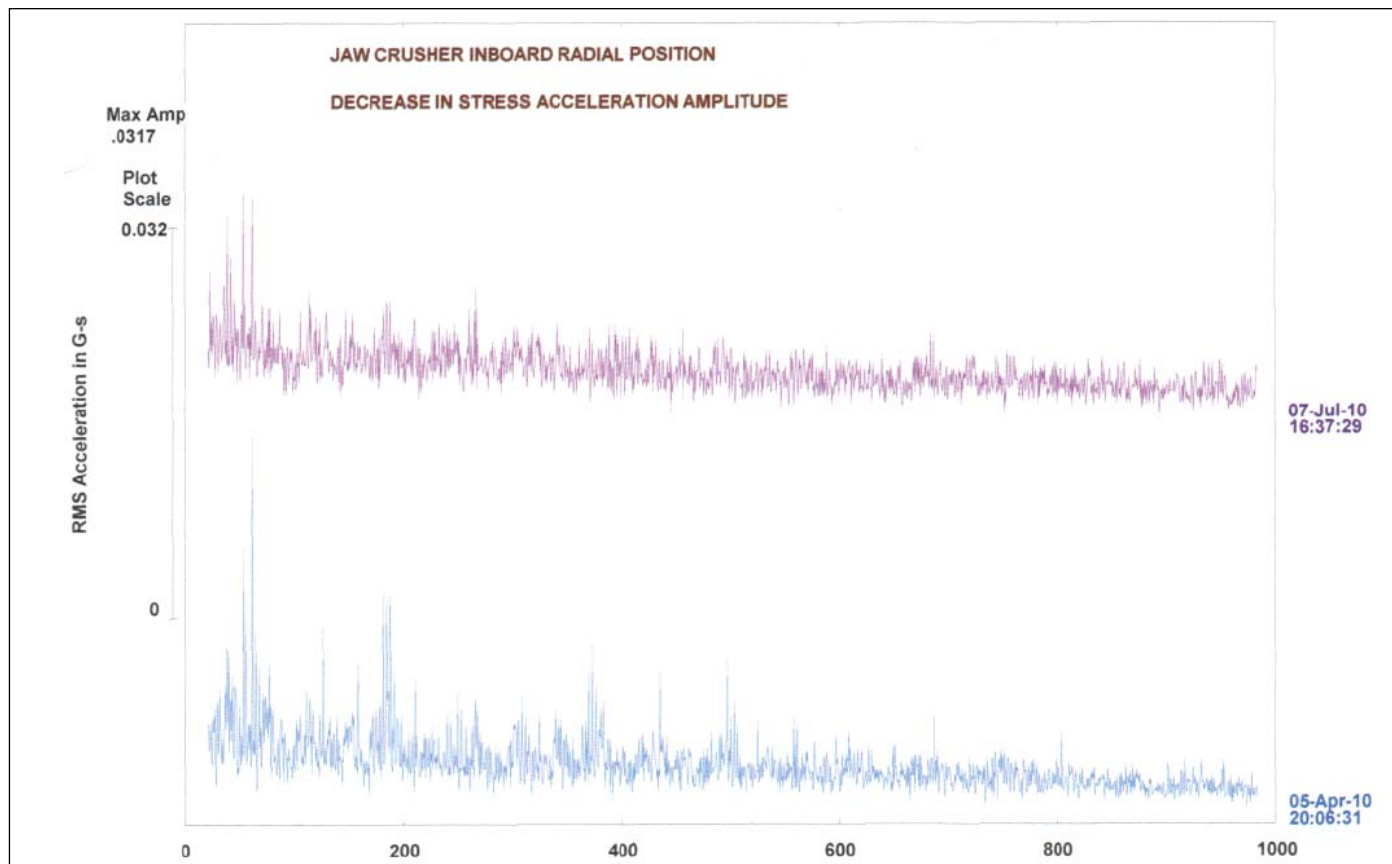
Figure 9 | Stress acceleration readings for the inboard shaft bearing.

a shaft operating speed of 188.8. This data was collected on the crusher at the inboard (flywheel) bearing position. There were eight positions collected, and six of the eight showed significant reduction in energy level, pointing to reduced contact energy. Operating load and speed conditions are the same during both measurement events.
